Final-- October 15, 1987

Preliminary Assessment
Rakonen Drum Site
Brigham City, Utah
UT0981545987

Preliminary Assessment
Rakonen Drum Site
Brigham City, Utah
UTD981545981

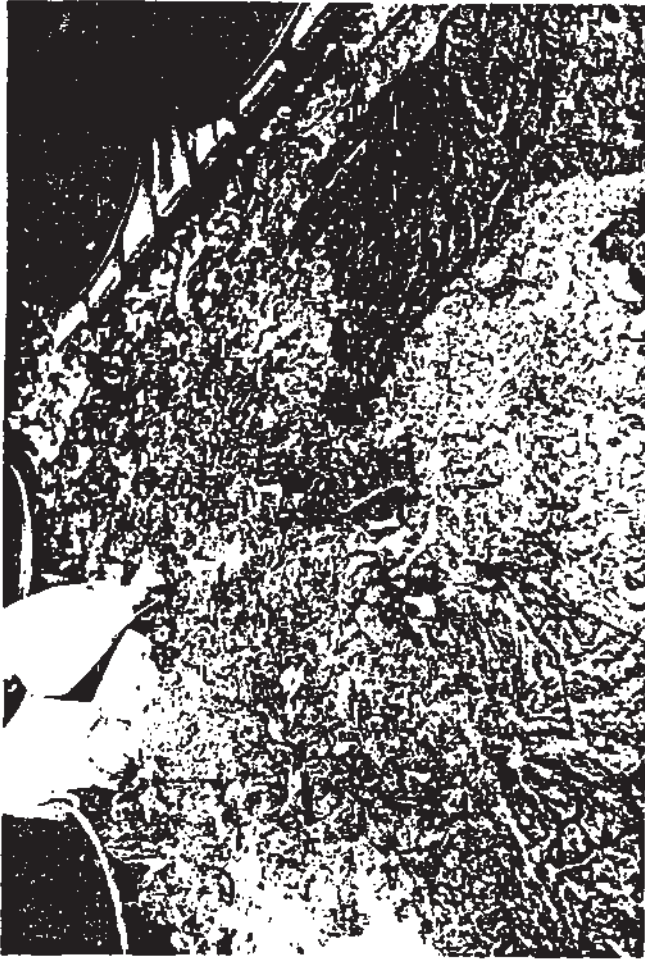
Photo of leaked materials in northern part of site.
More leaking drums.
